**PROPERTY CONDITION  
ASSESSMENT REPORT**

Kmart Shopping Center  
118-124 Waller Mill Road  
Williamsburg, York County, Virginia 23185

April 24, 2019 (Revision 1)

PSI Project No. 0443-1046

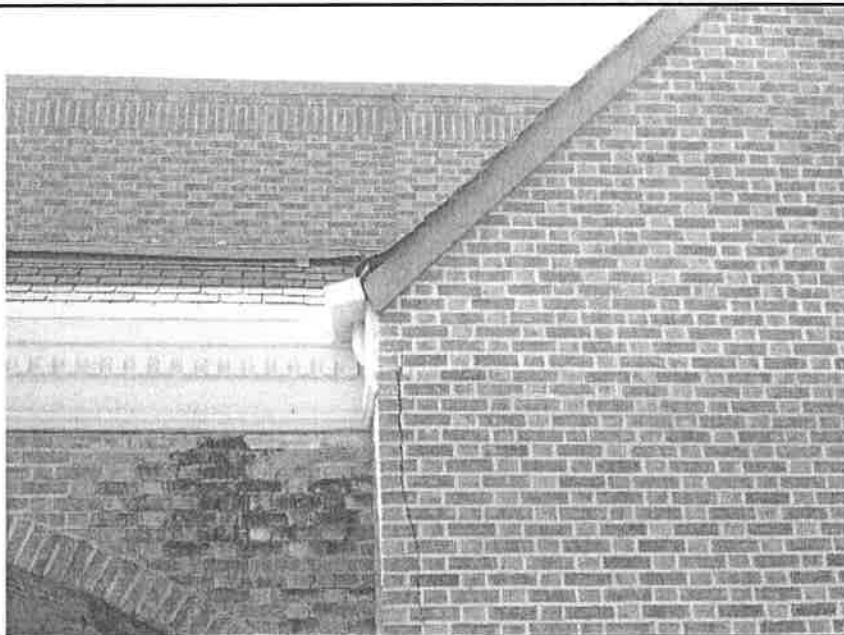
The exterior walls appear to be in generally fair condition. Isolated cracks in the masonry veneer were noted at two locations on the canopy area of the west building section. Masonry should be repaired to address cracks and remove/replace any loose components immediately. Masonry can last the life of the building with continued repointing, when needed. Vertical control joints are located approximately every twenty-five feet. The sealant appears to be in fair condition. Replacement of sealant joints at this time is not recommended.

**Photo 6:** Example of cracking in masonry veneer (photo provided by Client).

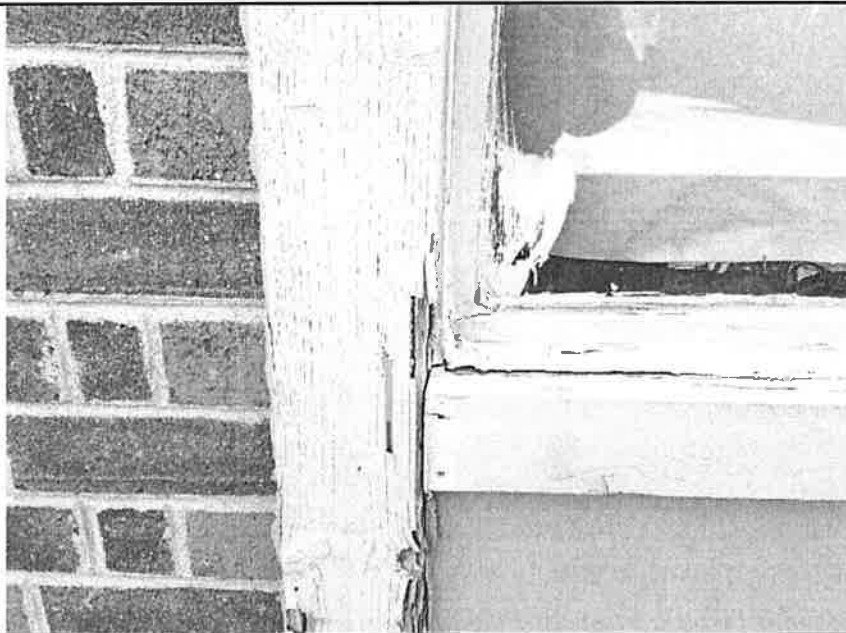
The exterior metal doors and windows of the Kmart space generally appear to be in good condition. The wood framing of the shop windows and doors are exhibiting rot and are recommended for replacement.

**Photo 8:** Typically observed deteriorated wood window trim.

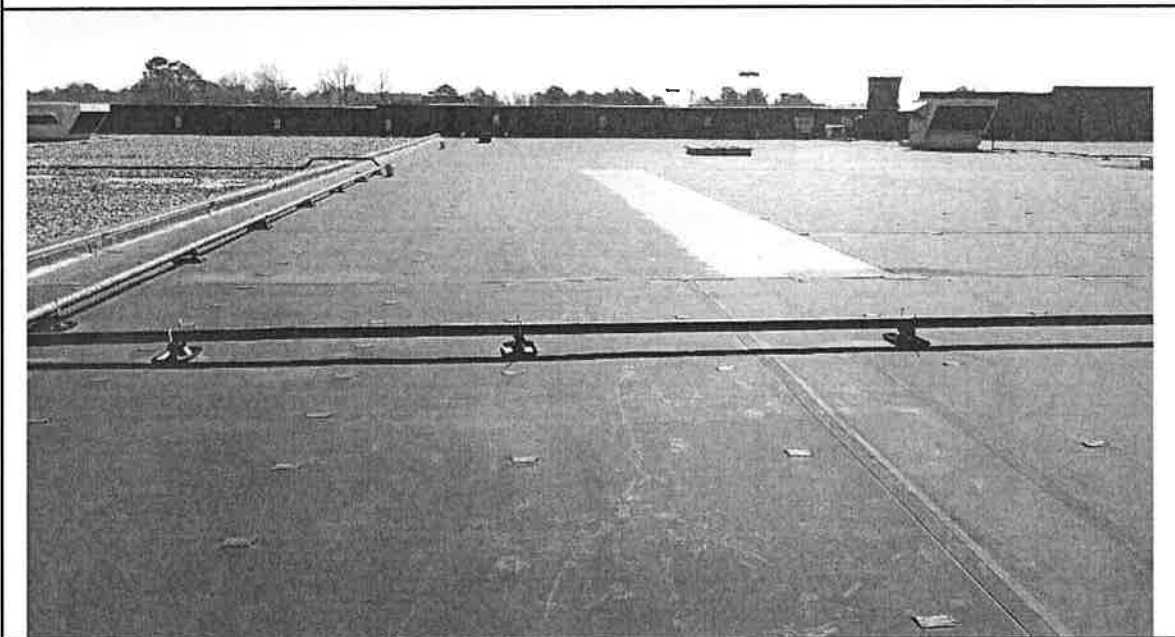
The Saturn type EPDM roofing over the Kmart appears to be in overall fair to poor condition. There were several of the Saturn type buttons securing the EPDM in place were observed to be missing and large repair areas to the EPDM were observed on the front roof area at the outdoor lawn and garden area. The Ballasted EPDM roof section is in poor condition. The stone ballast is displaced in numerous areas and previous repair areas were observed. PSI recommends replacement of this roof area.

**Photo 10:** Overview of Kmart roof.

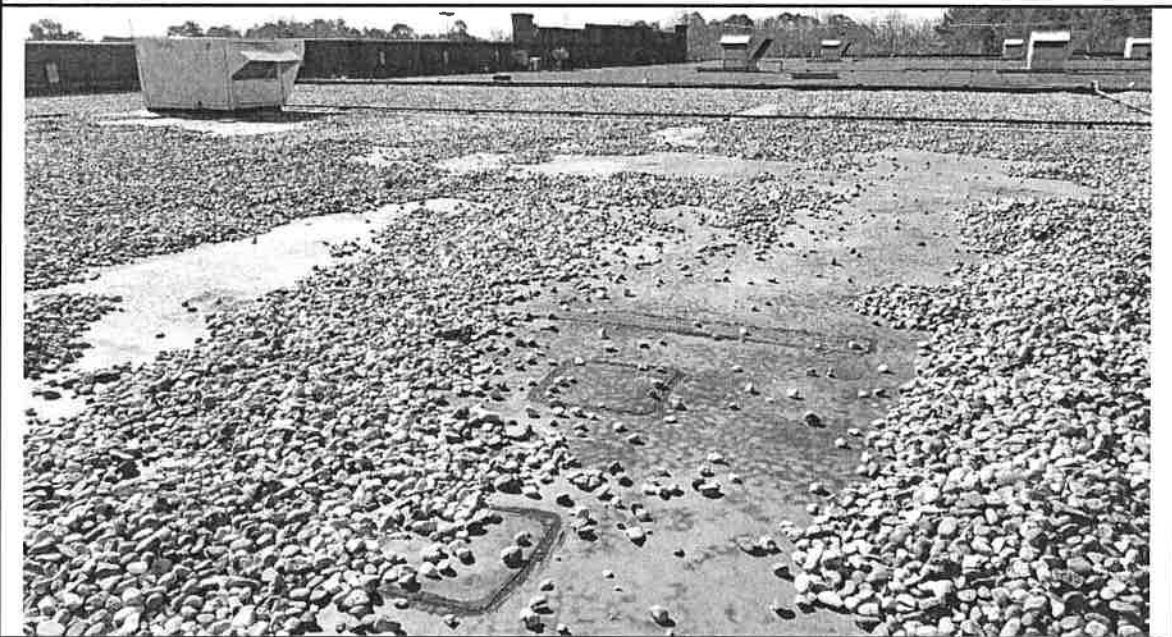
**Photo 12:** Displaced ballast along portion of Kmart roof.

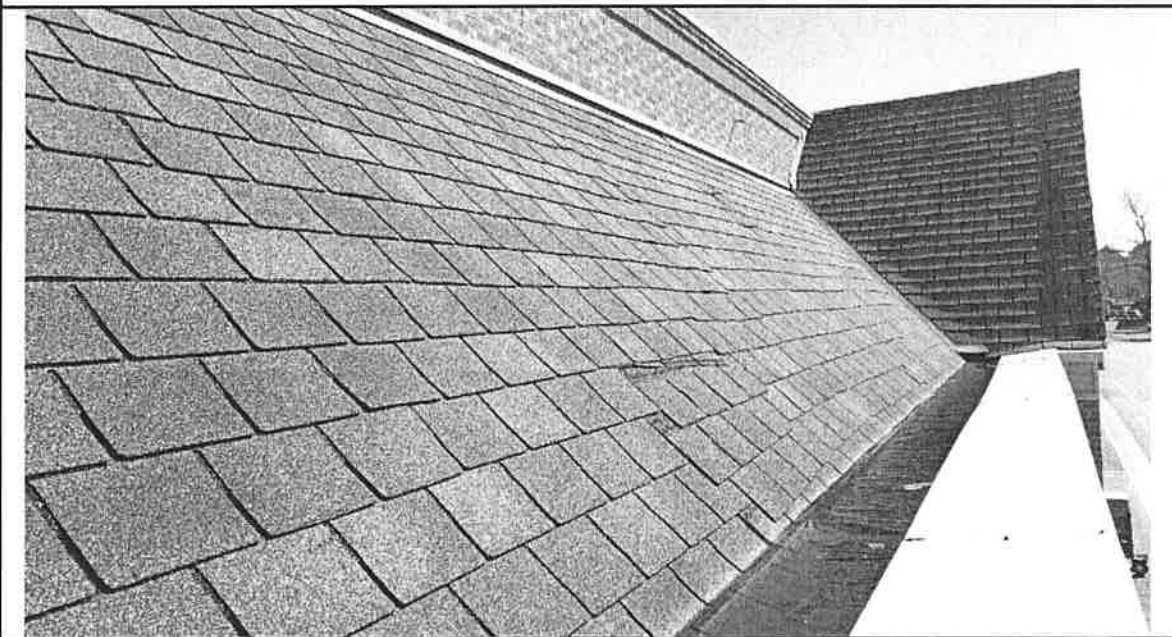
**Photo 14:** Asphalt shingle roof at entry canopies. Note clogged gutter.

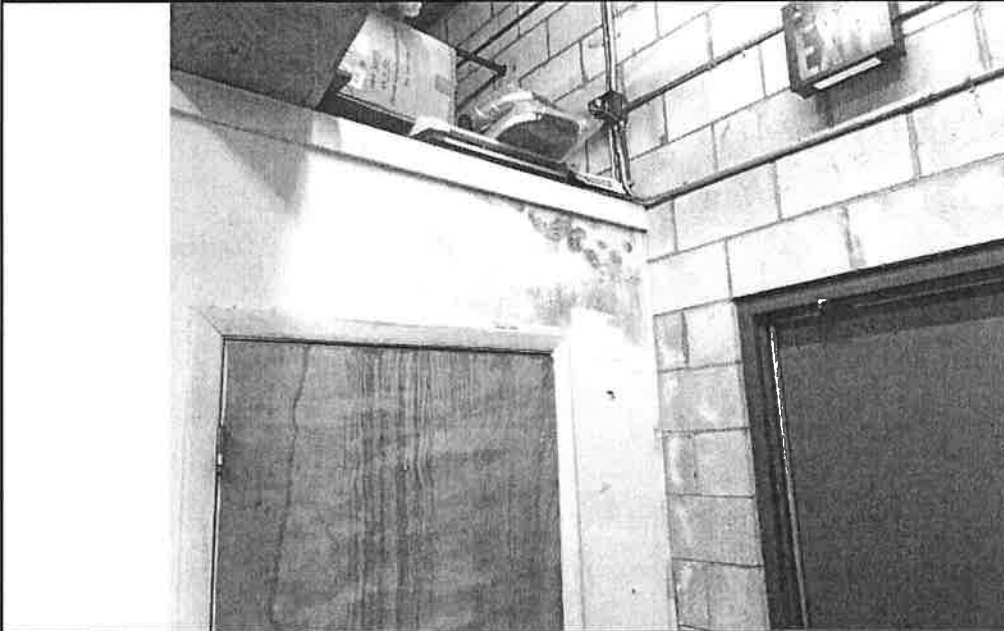
**Photo 28:** Example of staining, damage, and possible mold growth on interior finishes (photo provided by Client).
